CiDesign Firmware Release Note

Release model: iR16IS4ER / iR16IS2ER/ iR16SASER/iR16FC4ER

Version: 1.0.9 (20101208_1700)

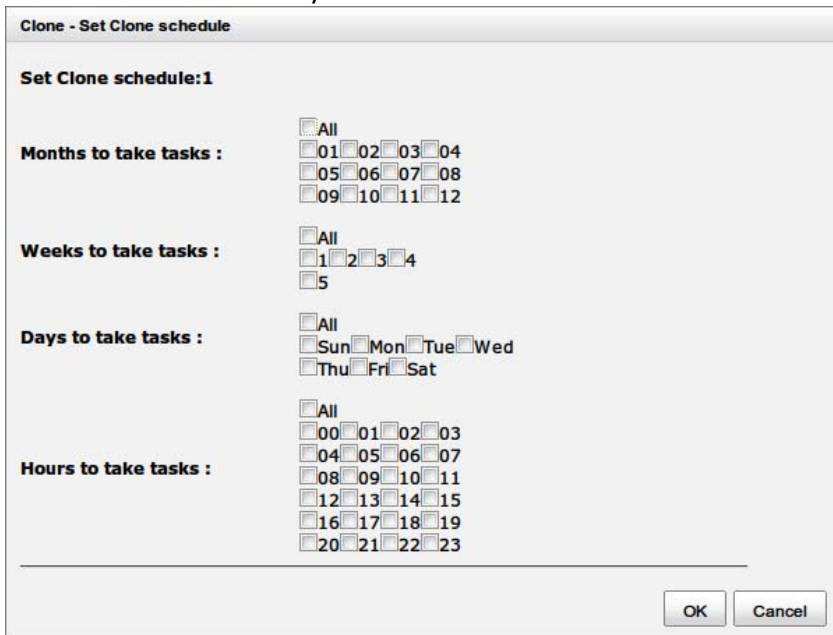
1. Add an event to notice user LUN mapping has change.
For example: When LUN mapping change, the system will issue event like below:
LUN number is attached to VD name.
LUN number is detached from VD name.
2. Add a warning level event ***"WARNING [CTR No.] RG name cannot be activated because of missing disks."*** if any one of raid group member disk did not exist during system power on.
3. Add VD clone schedule by hours.

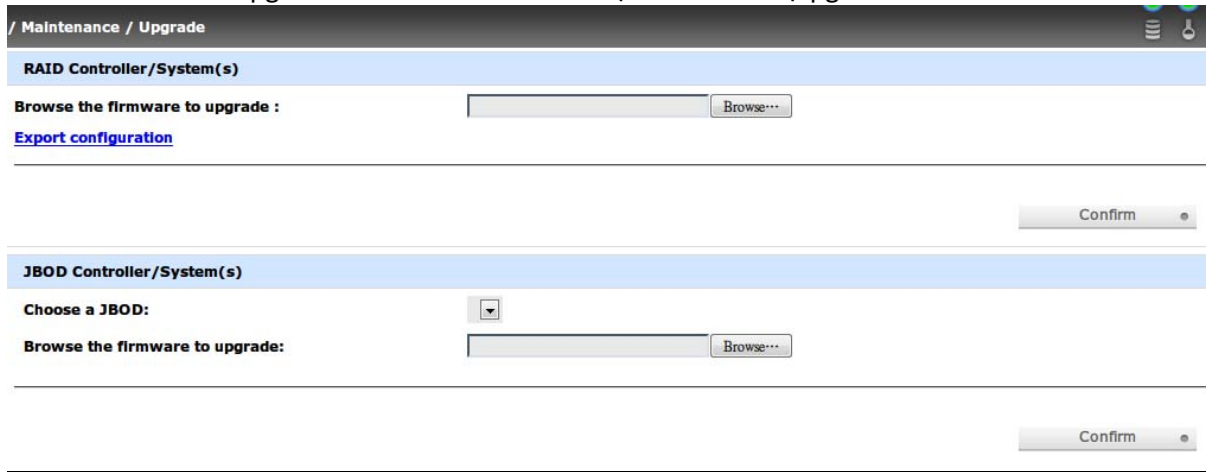
5. Break the 2TB physical disk limitation on Marvell SATA chipset model.
(iR16IS2ER)
6. Add JBOD FW upgrade function in WEB UI at \maintenance\upgrade

The screenshot shows a web interface for upgrading RAID and JBOD controllers. The top navigation bar indicates the current page is "/ Maintenance / Upgrade".
