# Bay LED Support on Cl Design NSR Unit Using I<sup>2</sup>C with 3Ware AMCC Controller Card

This manual will go through the information of using the I<sup>2</sup>C method with 3Ware Controller Card (9650 SE) on CI Design NSR Enclosures using Horizontal Backplane Board 12-6429-02A, 12-6429-05A, 12-6429-06A.

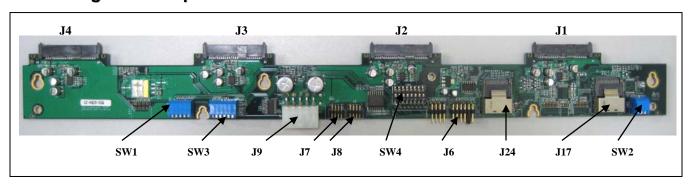
Figure 2 Backplane Board 12-6429-02A

HEADER	J6	Shunt-Jumper on pin 9 - 10					
SWITCH	SW1	All DIP keys → ON					
	SW3	DIP Key 1 → OI	N				
		DIP Key 2-6 → 0	OFF				
	SW4	All DIP keys → ON					
	SW2	Backplane Board	Card Port	SW 1	/2 DIP POS	SITION 3	
		Dodia		- 1			
		1	0-3	ON	ON	ON	
		_		ON ON	ON ON	ON OFF	
		1	0-3				
		1 2	0-3 4-7	ON	ON	OFF	
		1 2 3	0-3 4-7 8-11	ON ON	ON OFF	OFF ON	
		1 2 3 4	0-3 4-7 8-11 12-15	ON ON ON	ON OFF OFF	OFF ON OFF

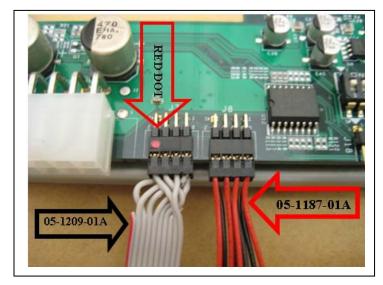
Figure 3 - I2C cable plugged into backplane

1. The I<sup>2</sup>C Cable 05-1209-01A must be installed on the First Backplane Board of the unit. Connect the 4x2 Cable Connector Housing to the J7 Header on the Board ("Red Point" of Housing Connector to pin #1 J7 Header). The SW2 of this First Board that connect to PORT 0 of the Card must be set to Binary 0 (ON ON ON).

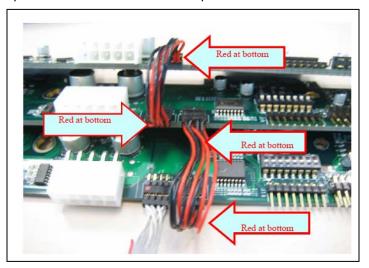
**Figure 4 Daisy Chain Connection**

- The next/ Second Board (if any) must be daisy chained with the First Board using cable 05-1187-01A
  on J8 and J7. Please be consistent in the way of connecting this cable (Red wires to Odd pin
  number). The SW2 of this Second Board that connect to PORT 1 of the Card SW2 must be set to
  Binary 1 (ON ON OFF).
- 3. Repeat similar step no.2 if there is additional backplane boards. Refer to Table 1 for SW2 setting.

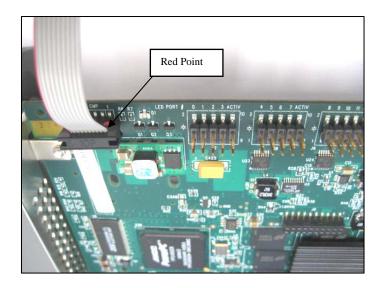
Figure 6 - I<sup>2</sup>C cable plugged into controller card

1. The I<sup>2</sup>C 5x2 Cable Connector Housing connects to the 3Ware Card I<sup>2</sup>C Header (The Red Point of the Cable Housing Connector to Pin-1 of Card Header).
